The Integrity Checks of KIWI-OSD and IOTA-VTI

by Dave of Kuriwa Observatory (E28), Australia

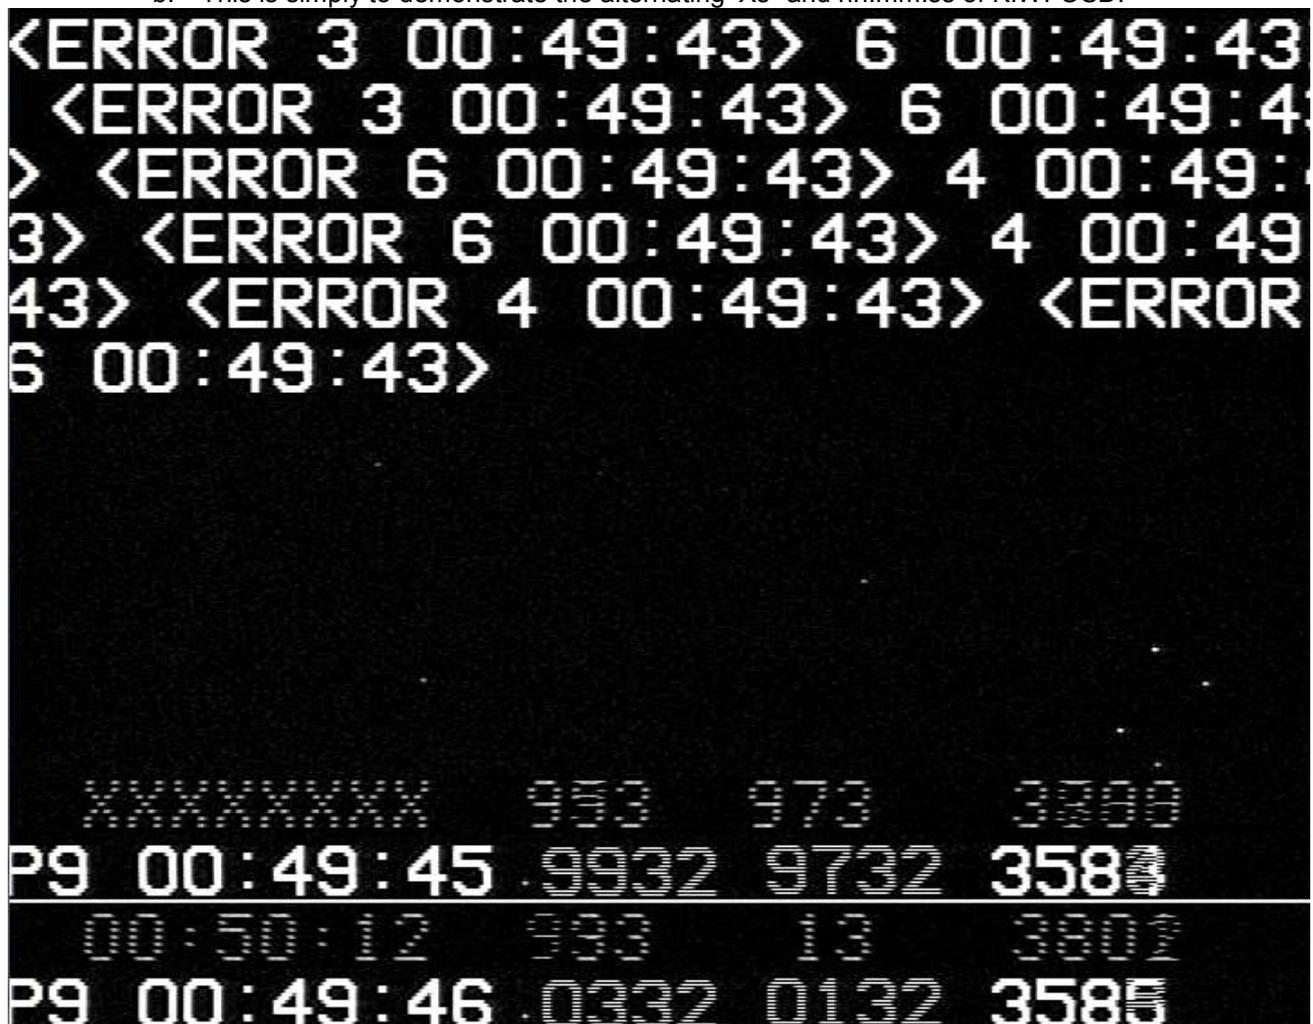
- 10) Here is one of the frames of that recording.
 - a. At the bottom of the frame is the timing display region of the next video frame.
 - b. This is simply to demonstrate the alternating 'Xs' and hh:mm:ss of KIWI-OSD.

- 11) Stepping through the videos frame-by-frame around the time of the integrity fault revealed no corruption of the sequence of 10th millisecond displays of IOTA-VTI and the millisecond displays of KIWI-OSD.
- 12) The field counters of both VTIs remained consistent for all videos.
- 13) Note: the hh:mm:ss display of KIWI-OSD, when not alternating with XXXXXXXX displays a time that is 27 seconds ahead of Universal Time.
 - a. All videos that display XXXXXXXX show a time that is many seconds ahead of Universal Time, to a greater or lesser degree as the sample shown above.

- 7) Post fault, the alternating hh:mm:ss - XXXXXXXX display of KIWI-OSD was shown to leap ahead of true Universal Time, (see example above) by 27 seconds. This is a serious problem.

- a. It would be much better if the display was a continuous XXXXXXXX, as the hasty observer may take the alternating hh:mm:ss display as true time.
 - b. The reason for the advance of the hh:mm:ss display is probably the detection of false 1pps signals.

- c. Since a product recall is not feasible for a discontinued product, it would be appropriate to publicize this situation in all IOTA journals, thereby minimizing the chance of reporting erroneous timings.
